Group H

Site Summary Group H
AREA IV
Santa Susana Field Laboratory, CA

Site Summary – Building 4073

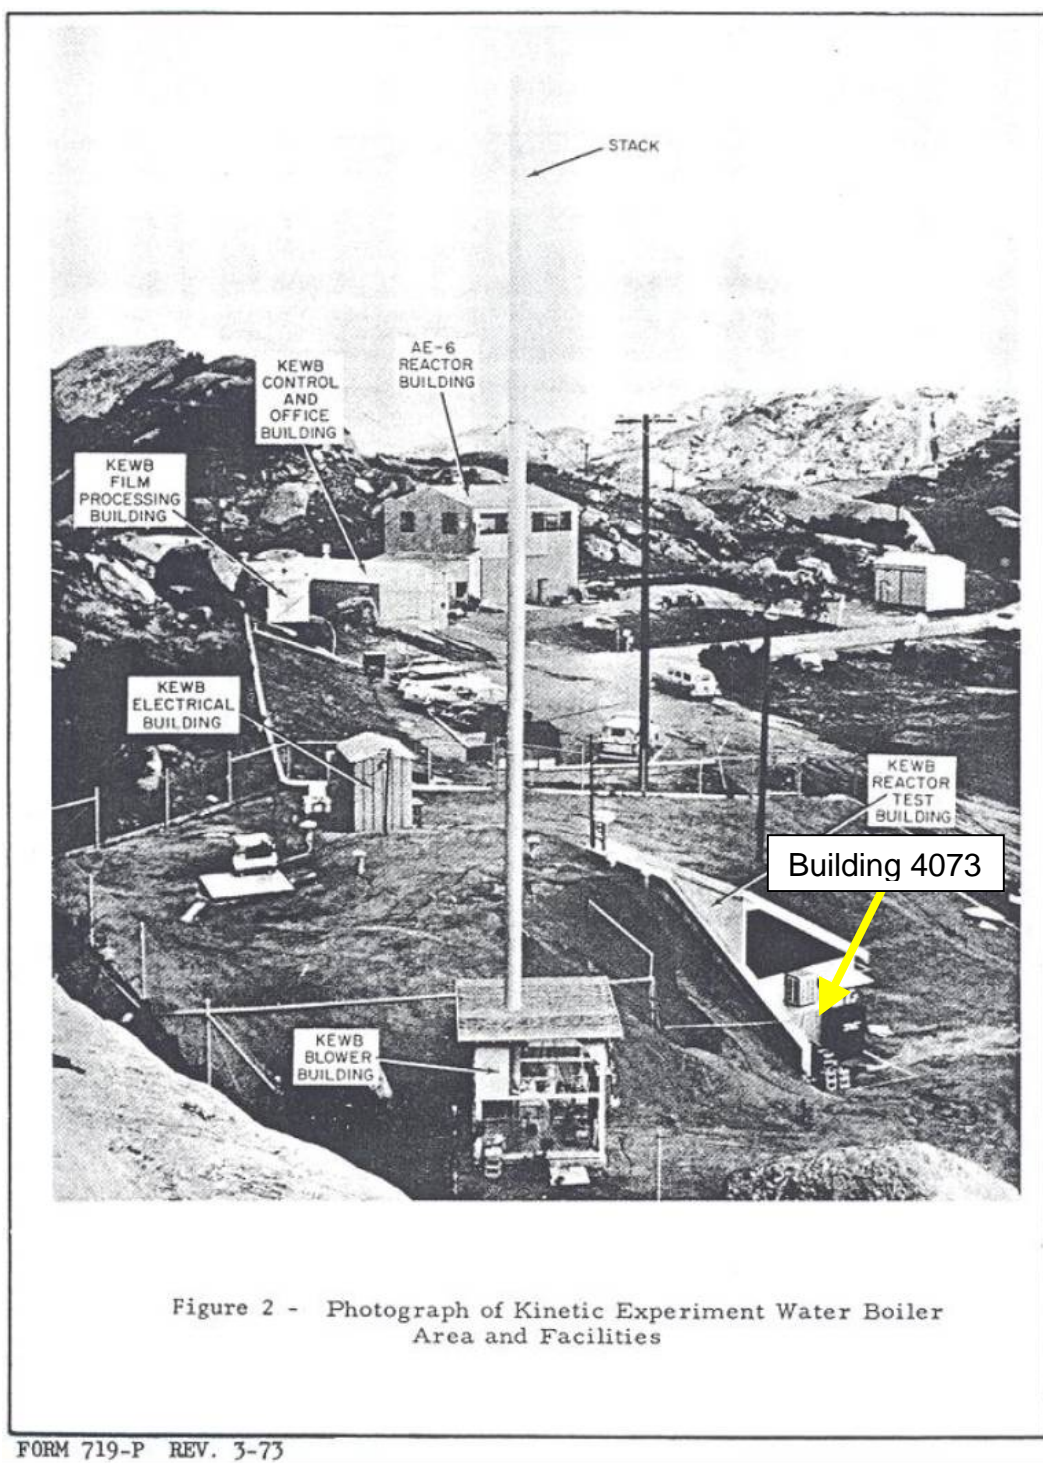
Photograph – Building 4073

- Building 4073 was demolished in 1975.⁵
- The Energy Research and Development Administration released the facility and surrounding area for unrestricted use in 1976.²

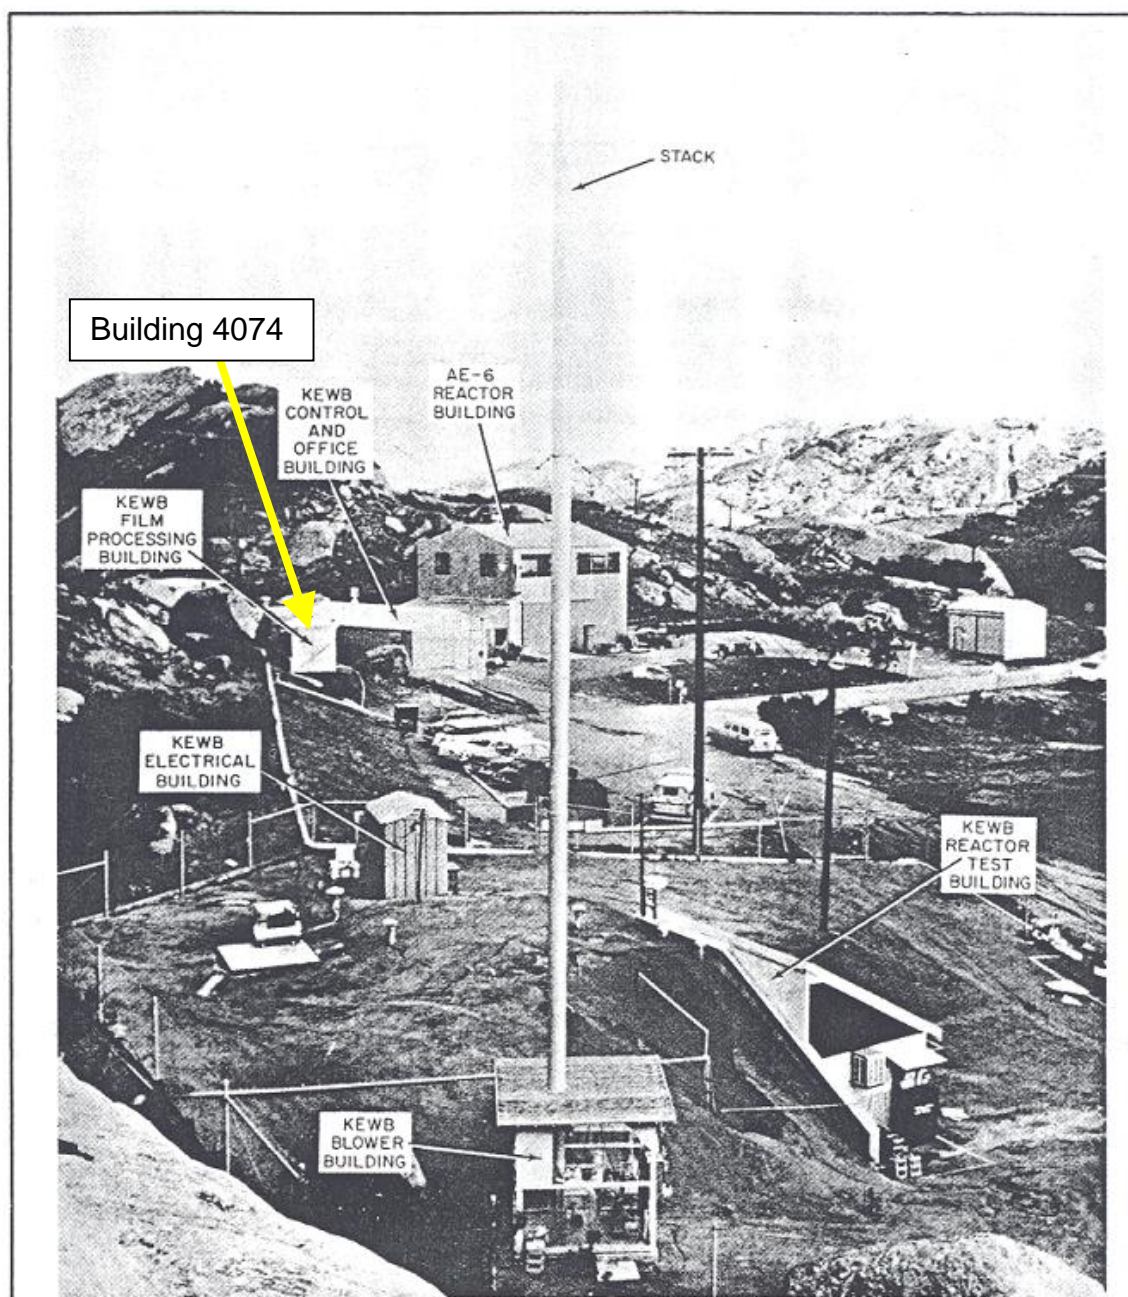
Photograph – Building 4074

- NRC released the site for unrestricted use in 1987.²
- Building 4074 was demolished in 1995.

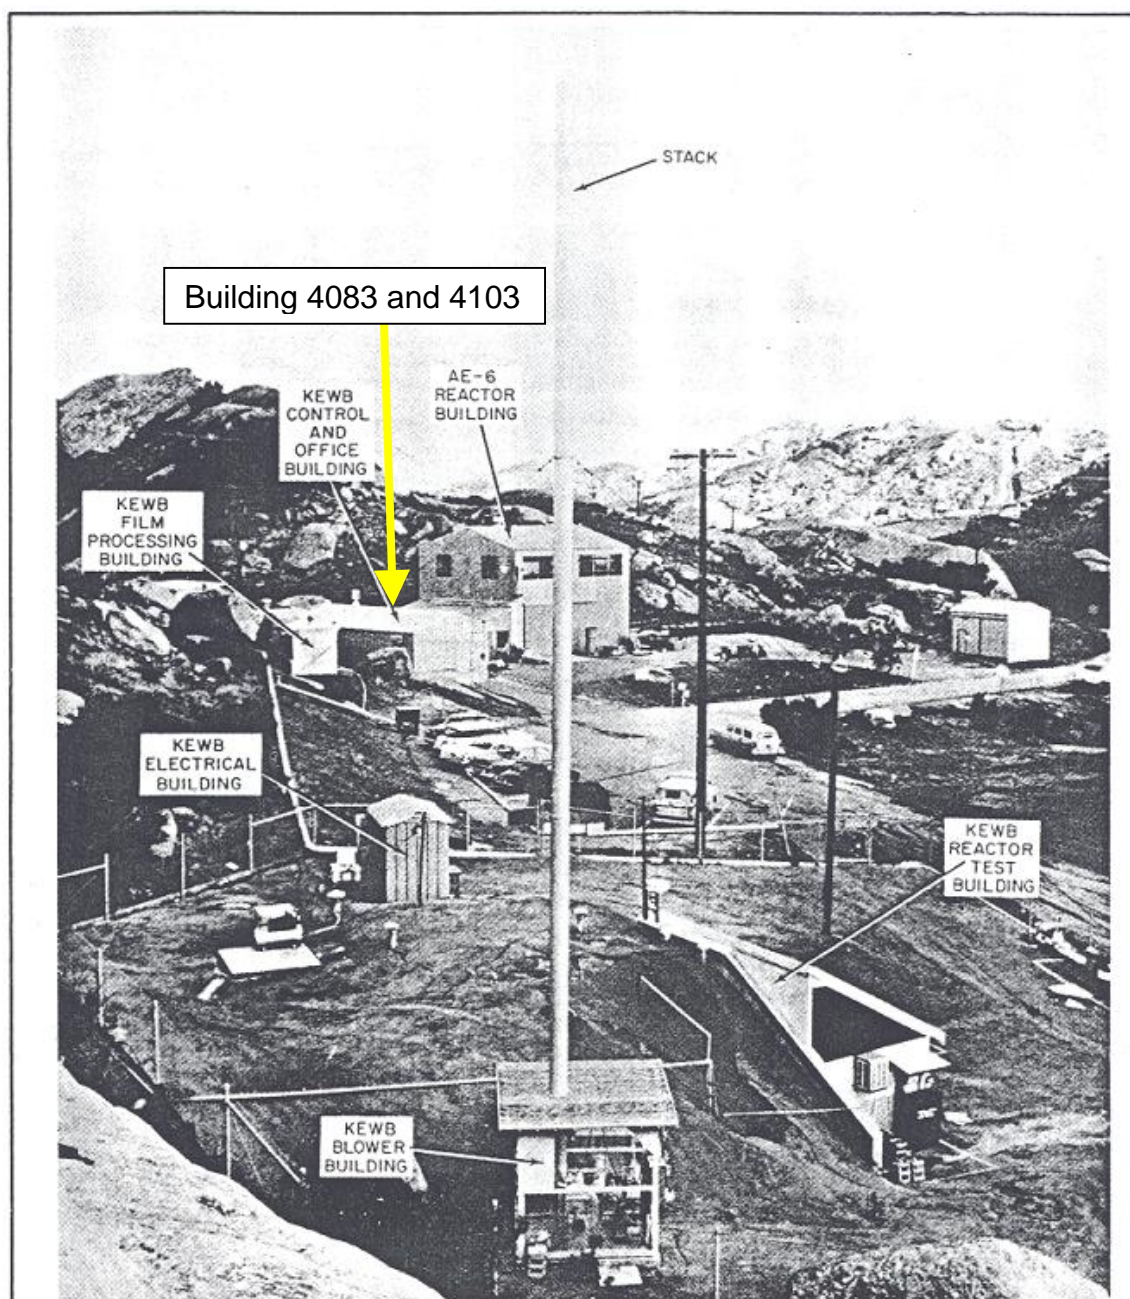
Photograph 1 – Building 4083 and 4103

- NRC released the site for unrestricted use in 1987.²
- Building 4083 was demolished in 1995.

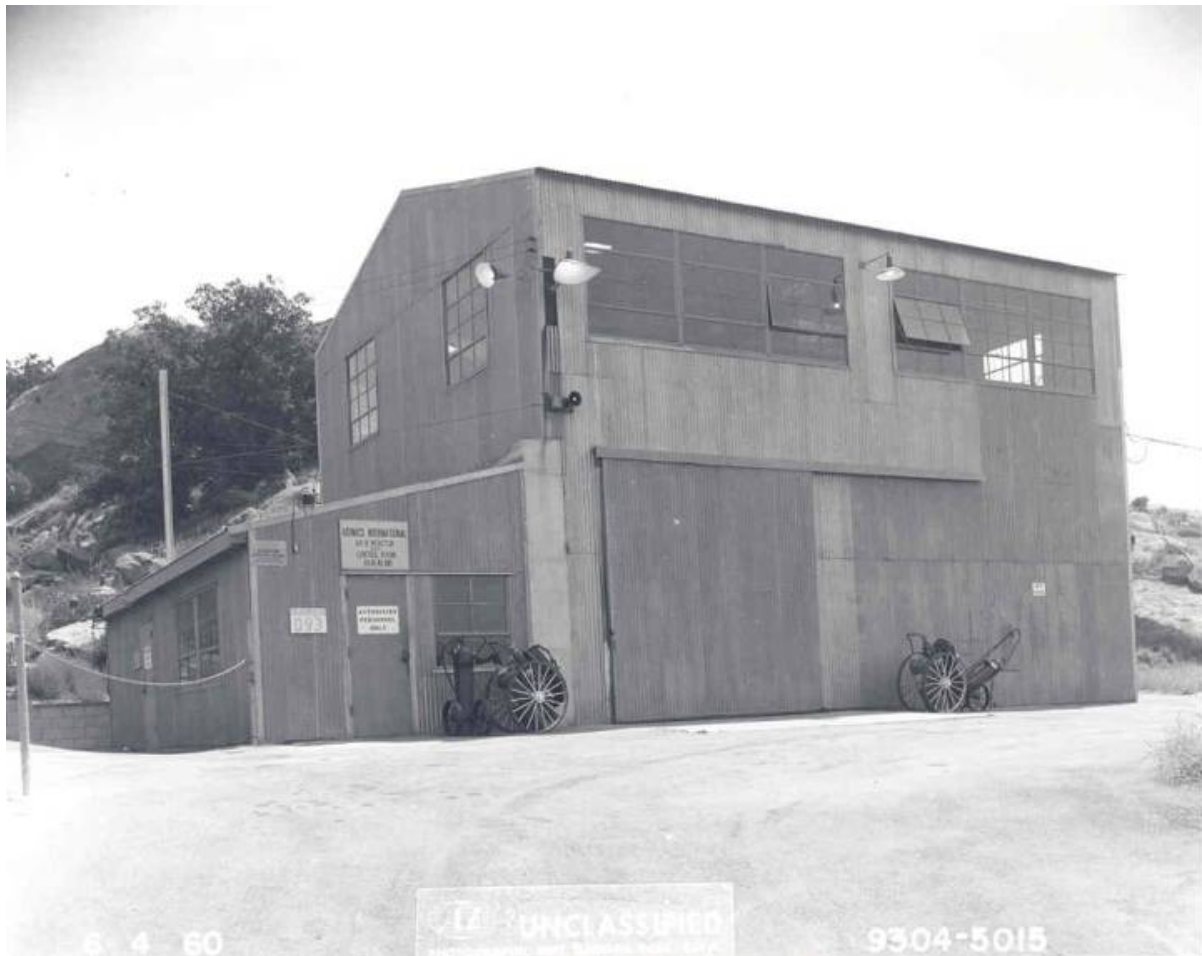
Photograph 1 – Building 4093

- The maximum ambient exposure rate was originally found to be 21.3 µR/hr (limit is 18.9 µR/hr). The concrete was removed from areas measuring over the limit and the re-survey showed them all to be under the limit, with the highest measurement at 18.2 µR/hr.

- NRC released site for unrestricted use March 19, 1987.²
- The facility was demolished leaving only the foundation in 1995.

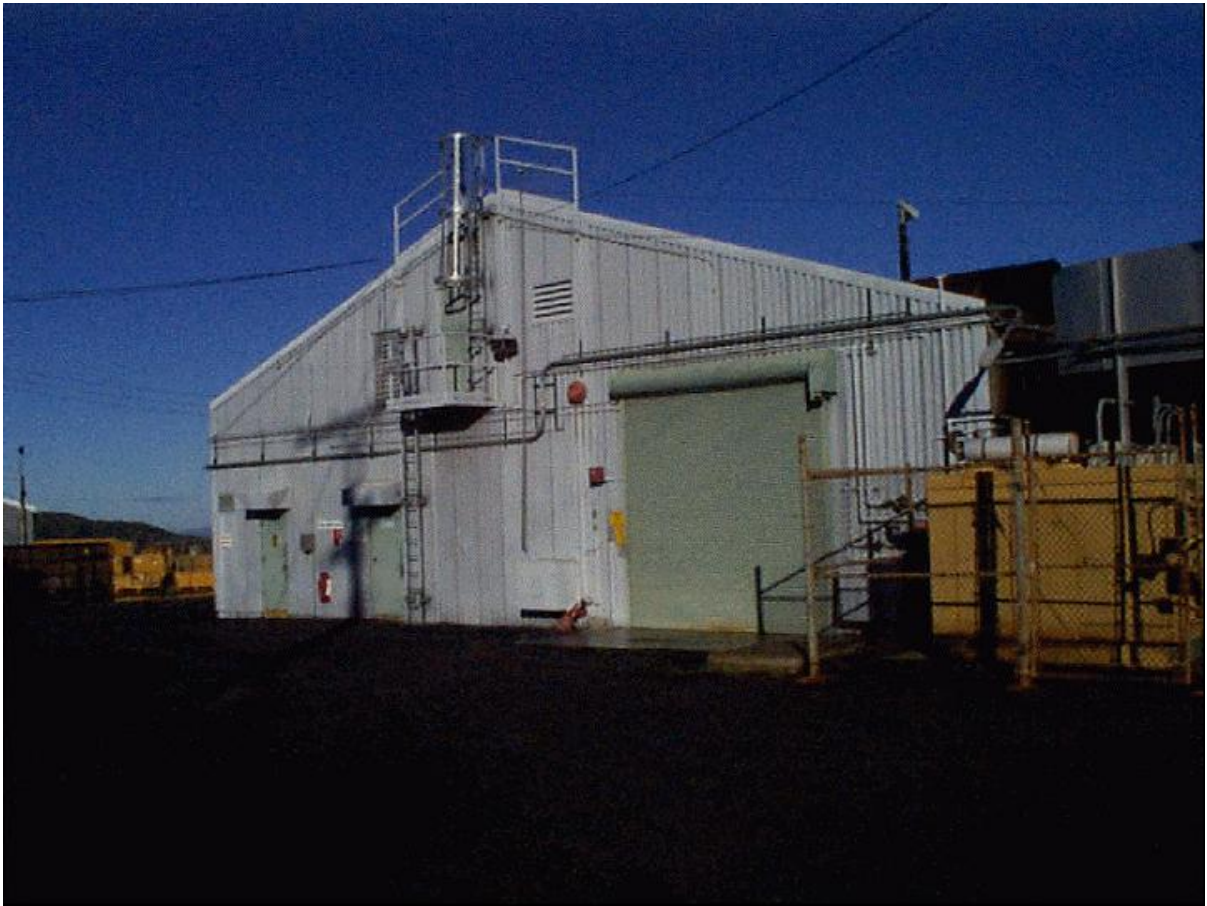
Photograph – Building 4021

- On November 3, 1976, the leach field connected to the building was found to be contaminated at levels up to 200 mrad/hr (A0056).
 - On February 15, 1978, the contaminated leach field flooded with rainwater, resulting in the release of water contaminated with Sr-90 at a level of 4×10^5 $\mu\text{Ci/ml}$ gross beta activity (A0064).

- Decontamination and removal activities occurred from 1976 to 1978. Approximately 36,250 cubic feet of contaminated soil and sludge were shipped to radioactive waste disposal sites. An estimated 0.6 mCi of radioactive material remains sequestered in inaccessible recesses and three contaminated cracks in the bedrock.

- The site was left with a minor amount of radioactive material in three cracks in the sandstone rock (estimated 0.6 mCi). The cracks are over 10 feet below the surface and were sealed with bituminous asphalt mastic.

- Building 4021 is active.
- The Building 4021 leach field was recommended for release for unrestricted use by the Department of Energy (DOE).²

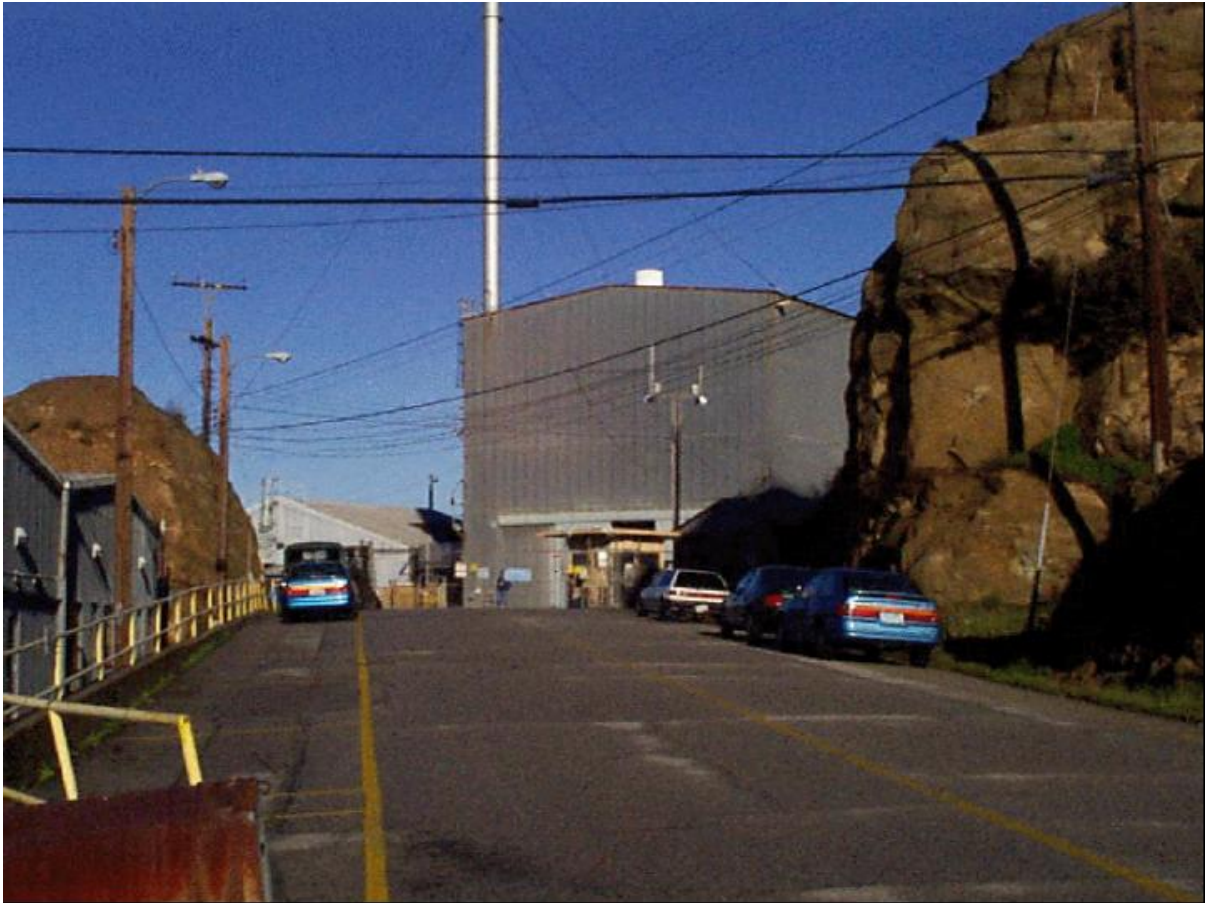
Photograph – Building 4022

- On December 29, 1965, drums of contaminated sodium exploded in a rain storm and burned the outside of the building (A0588).
 - On May 21, 1967, a drum of uranium carbide sludge exploded on a truck outside of the building, contaminating asphalt and evaporator equipment. Contamination levels ranged from 300 to 5,000 dpm/100 cm². Decontamination of the asphalt and equipment was successful (A0615).

- On May 22, 1978, the sump pump stopped working and contaminated liquid flowed out of a holdup tank, contaminating asphalt, which later contaminated eight truck tires placed on the pavement. Both the tires and the asphalt were decontaminated (A0070).
- On August 14, 1979, a shipping box loaded on a waste truck for offsite disposal leaked radioactive liquid containing Cs-137 and Sr-90 on the asphalt outside RMHF. The area was successfully decontaminated shortly after the incident (A0314).
- Because of the operational and incident history of this building, as well as the entire RMHF facility, the building and its surroundings will be surveyed and decontaminated at the time of RMHF closure.

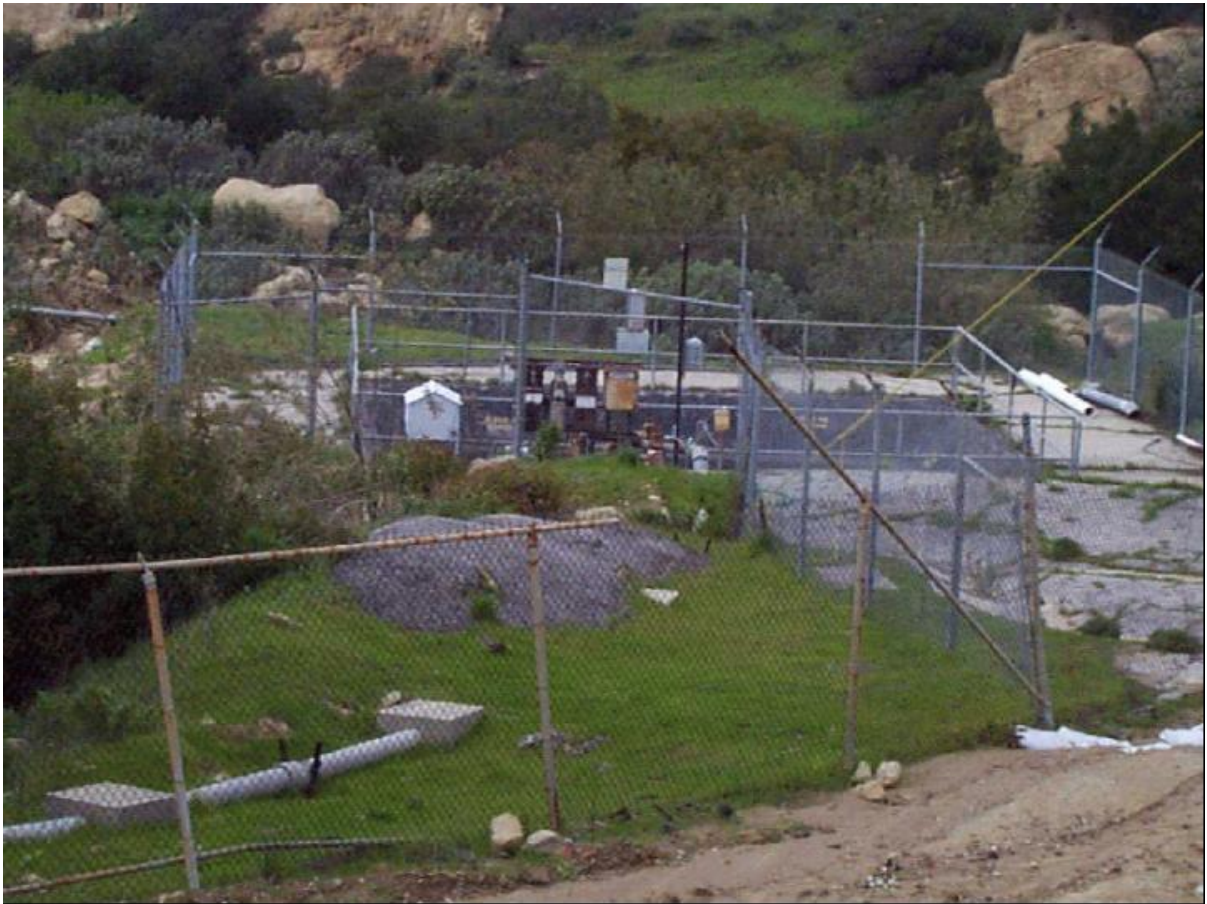
Photograph – Site 4614

- Radioactive contamination exists in the pond as a result of known spills that have occurred at the RMDF/RMHF.
- There have been two notable radiological incidents associated with Site 4614:
 - On January 17, 1979, leakage from the flocculation tower associated with Building 4021 contaminated the drainage ditch and the pond itself with less than 0.4 mCi of Sr-90 and Cs-137 (A0077).
 - On January 9, 1980, a water hose broke, causing the Building 4021 tank to overflow, which then drained to the pond. This incident resulted in the released of about 100 gallons of liquid containing 1×10^{-2} mCi of mixed fission products (A0080).

- There have been several surveys of the entire RMHF complex, including Site 4614, during its operation. The results of these surveys are summarized in the 4021 site summary.
- Due to operational history, Site 4614 is likely contaminated.
- Site 4614 is monitored and alarmed by a NaI gamma exposure meter. Any alarms result in immediate sampling of the water. All alarms in the past 14 years have been false alarms caused by power supply and telephone line problems during wet weather. No activity has been detected in the water. Water pumped from this pond into the Santa Susana Field Laboratory (SSFL) water reclamation system is ultimately sampled according to the National Pollutant Discharge Elimination System (NPDES) permit.²

- During the dry season when the pond dries up, the sediment is removed from the lined pond and analyzed for contamination prior to being disposed of as radioactive waste. Low levels of Cs-137 are frequently found (e.g. 34 pCi/g in 2003).⁴
